Manhole Inspection Summary

Manhole # S01YY1005MH

Insp Date: **7/28/06 7:39 AM**

Location Address: **3404 W Strathmore Ave**

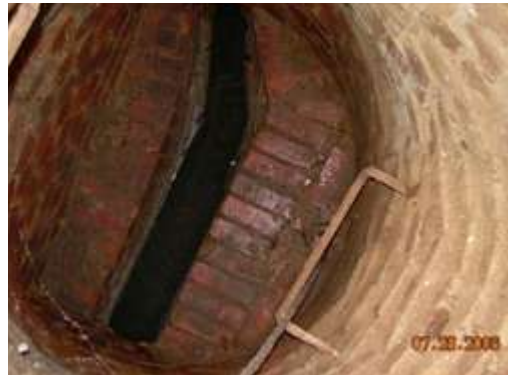
Top View

Condition: ☐ Sound ☐ Cracked ☐ Root Intrusion ☒ **Loose Brick** ☐ Deteriorated

Infiltration: ☐ None ☒ **Joint** ☐ Cracks ☐ Mortar ☐ Roots ☐ Wall

Infiltration: ☐ None ☐ Joint ☐ Cracks ☐ Mortar ☐ Roots ☒ **Wall**

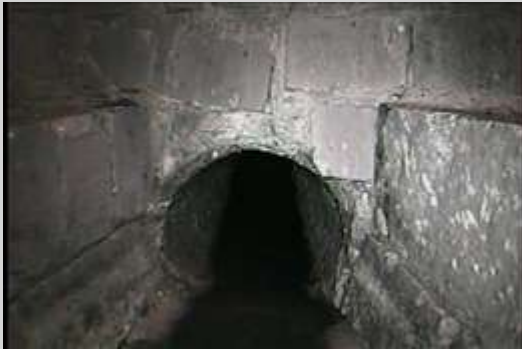
6 in. Circular Gravity Sewer Pipe Out @ 12 O'Clock

Pipe Material: **Clay** ☐ Pipe Lined

Invert Depth: **5.70** (ft.) Flow Characteristics: **Slow**

Infiltration: **None** Pipe Seal Cond: **Sound**

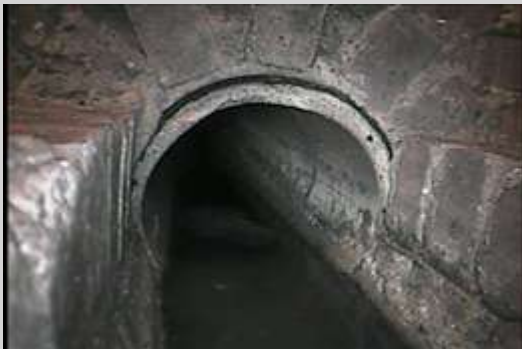
8 in. Circular Gravity Sewer Pipe In @ 7 O'Clock

Pipe Material: **Clay** ☐ Pipe Lined

Invert Depth: **5.80** (ft.) Flow Characteristics: **Slow**

Infiltration: **None** Pipe Seal Cond: **Sound**
